Dynamic assessment of a stress-ribbon CFST arch bridge with SHM and NDE

In the current study, an onsite investigation of an arch pedestrian bridge is performed by using VBM and NDE. The current study follows a previous research work on the same structure (He et al. 2022). The local defects of the main arches, known typically as debonding/void of the concrete core is the focus of the current work. Ultrasonic testing was implemented to assess the condition of the Concrete-Filled Steel Tubular (CFST) composite sections. In addition, the deck system of the bridge, known as the stress ribbon, is composed of several precast concrete segments. Evaluation of the compressive strength and hardness of the concrete slab is conducted by the rebound hammer testing. The results of structural identification obtained by the FE model updating method are then presented. Fidelity of the updating results will be addressed in reference to the findings of NDE for the identified model parameters.

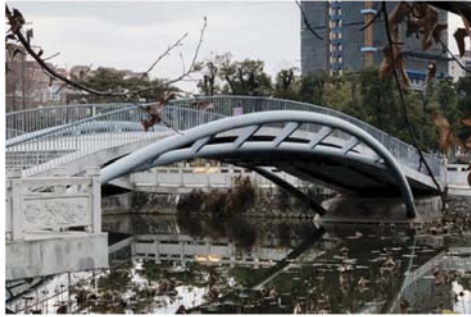
As shown in Figure 1, the stress-ribbon deck of the pedestrian bridge is supported by the cross beams between the outward inclined CFST arches, also known as the butterfly arches. Since the stress ribbons were anchored to the abutment where the springs of the arches were rooted, the whole structure consists of the self-anchored system, which loads the foundations mainly in the gravity direction. The span of the main arches is 25 meters with the rise of 5.5 meters. See Figure 2. They are made of the 42.6cm-diameter steel pipes with the thickness of 1.6 cm. The angle between the inclined arches and the ground is 60 degrees. The span of the secondary arches is 16.8 meters. They are made of the 37.7cm-diameter steel pipes with the thickness of 1.6 cm. The connections between the main and the secondary arches are welded. They are also interconnected by seven rigid hangers on each side. The stress-ribbon deck was assembled from the precast concrete segments by using two pre-stressed tendons. Each of the precast segment is 6 meters in width, 1.15 meters in length and 14 cm in thickness. The tendons are formed by two bundles of 12×Φ15.2mm monostrands grouted inside the galvanized steel pipes. The middle part of the bridge deck simply rests on the cross beams, whereas the side parts of the bridge deck are supported by the pre-stressed tendons. See Figure 3.

Figure 1. A stress-ribbon CFST arch pedestrian bridge at Fuzhou university.

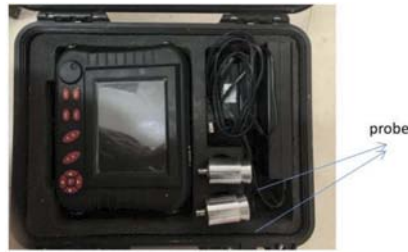
Debonding is the common structural defect of the CFST members in an arch bridge (Chen et al. 2022). They can usually be assessed by using the ultrasonic testing method. Shown in Figure 4 is a typical sound wave transmission detector for quality testing of the CFST construction.

Figure 4. Ultrasonic instrument: WE-520 sound wave transmission detector (operating at 50 kHz).
