The unusual Ca' Bonettini landslide (Province of Modena, Italy) / Tosatti, Giovanni. - In: ATTI DELLA SOCIETÀ DEI NATURALISTI E MATEMATICI DI MODENA. - ISSN 0365-7027. - STAMPA. - 137:(2006), pp. 145-156.

Giovanni Tosatti*

The “unusual” Ca’ Bonettini landslide (Province of Modena, Italy)

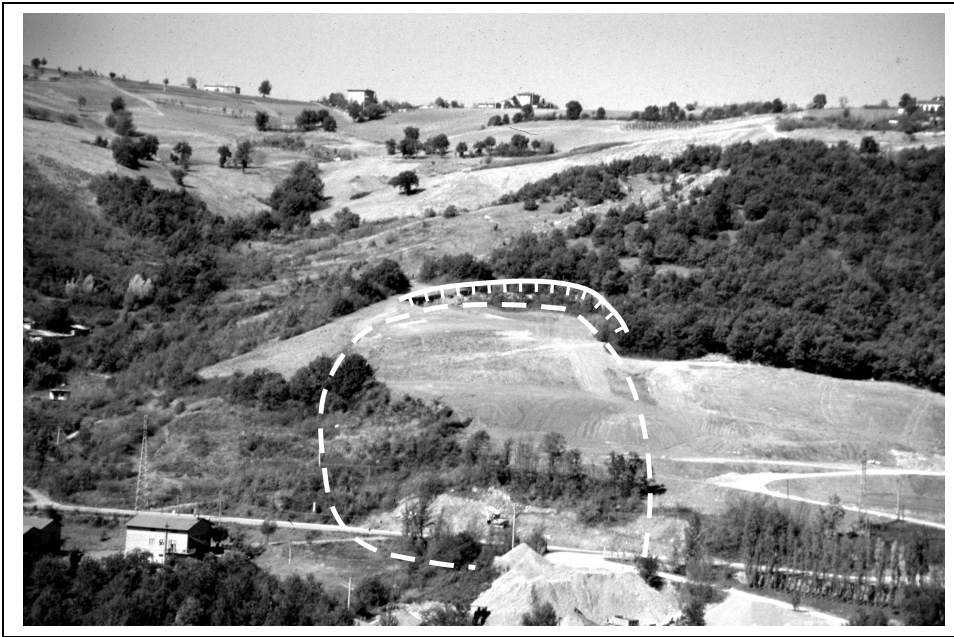
Fig. 1 – Panoramic view of the slope where the Ca’ Bonettini landslide took place. Broken lines represent the landslide’s crown and body (courtesy of D. Castaldini)

Early on 15th September 2003 a slope movement took place near Ca’ Bonettini, a group of houses in the Municipality of Marano sul Panaro (Modena Apennine hills), on the left-hand side of the River Panaro valley (Fig. 1). According to seismological data, an earthquake, VII-VIII degree MCS, 5.2 magnitude, was recorded late on 14th September 2003 in the nearby Bologna Apennines.
