Geomorphological analysis of the historic landslide of Sottrù (Badia Valley, Italy) reactivated on December 13, 2012 / Ghinoi, Alessandro; Freddi, Raffaele; Pasuto, Alessandro; Soldati, Mauro. - ELETTRONICO. - (2014), pp. 1-8. ( International Conference "Analysis and Management of Changing Risks for Natural Hazards" Padova 18-19 novembre 2014).

**Geomorphological analysis of the historic landslide of Sottrù (Badia Valley, Italy) reactivated on December 13, 2012**

**Ghinoi, A.<sup>1</sup>, Freddi, R.<sup>1</sup>, Pasuto A.<sup>2</sup> & Soldati, M.<sup>1</sup>**

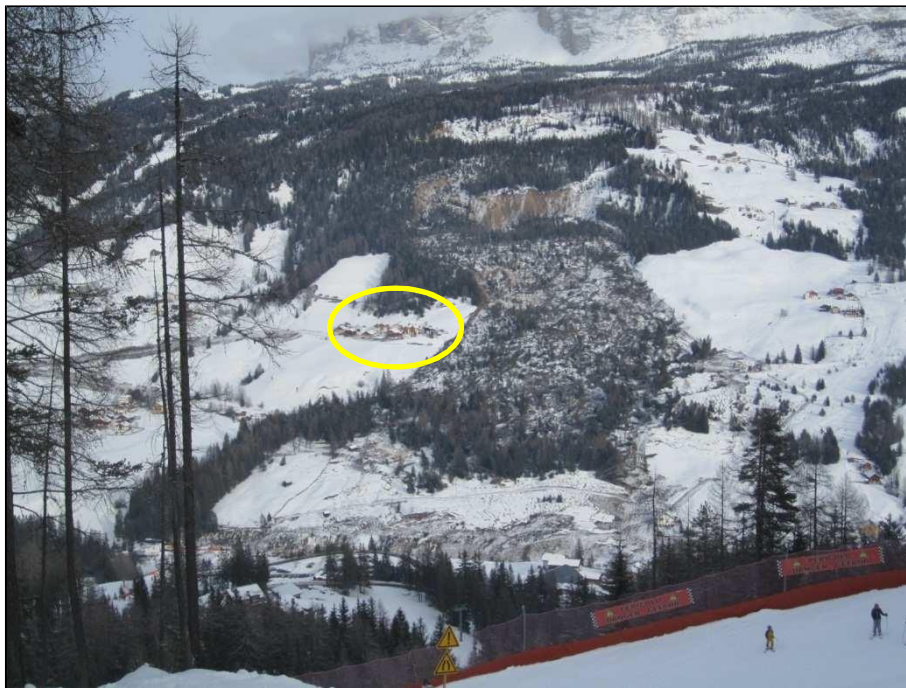
Figure 3. Front view of the 2012 landslide event taken some days after its occurrence. The village of Sottrù is identified by the yellow ellipse. Photograph by M. Soldati.

The geomorphological survey of the Sottrù landslide occurred on 13 December 2012 (Figure 3), performed during the summer of 2014, was aided by the use of a GPS track logger, allowing the precise mapping of geomorphological, hydrographic and hydrogeological details. Important reference maps of the area were the “Carta Geomorfologica dell’Alta Val Badia” and its reference notes (Panizza et al., 2011), and the “Carta Geologica delle Dolomiti Occidentali 1:25.000” (Brandner et al., 2007).

Until a few metres below the village of Sottrù, the lateral scarps are well visible although thinning up. Below Sottrù the accumulation zone starts, reaching the Gadera torrent. From Figure 3 the hummocky morphology characterising the whole toe area can be appreciated.

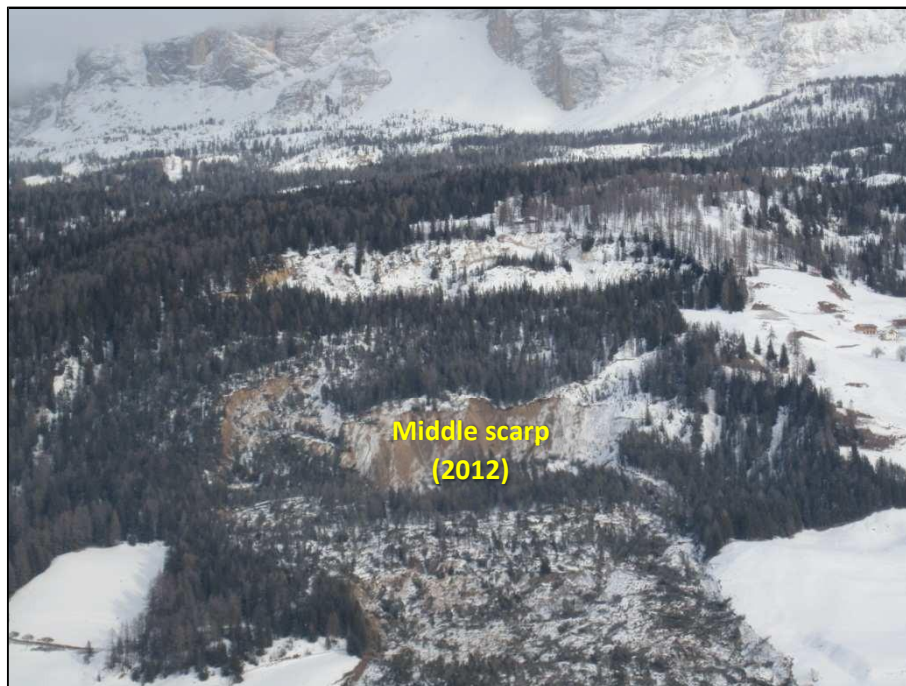
Figure 5. Middle scarp of the 2012 event and related landslide accumulations. Photograph by M. Soldati.

The same evolution seems to have characterised also the left part of the middle scarp, where the sliding uncovered an outcrop of the Wengen Formation layers. Field evidence in the days just after the event, when maximum daily temperatures were still around 0°C, shows water discharges starting from the base of the detrital cover and reaching the base of the scarp, testifying the presence of unfrozen subsurface water.

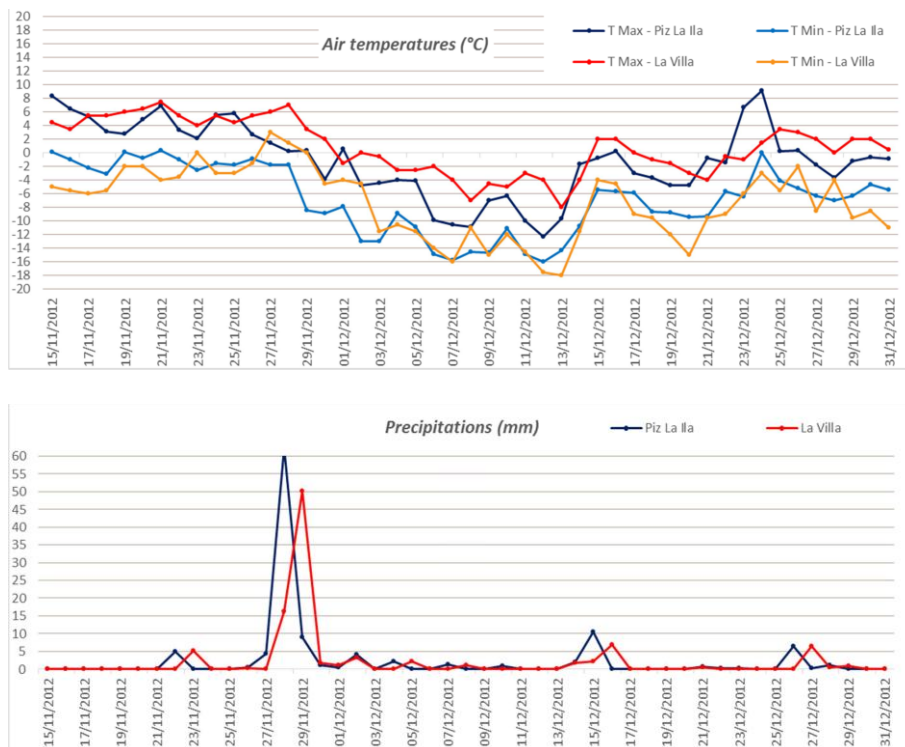
Figure 6. Meteorological time series, recorded at two local stations from 15 November to 31 December 2012.

namely of daily minimum and maximum air temperatures and precipitation height. The data were taken from two local meteorological stations: one placed in the village of La Villa, at 1390 m a.s.l., and one on top of the mountain peak “Piz la Ila”, at 2050 m a.s.l. As it can be appreciated from the plots in Figure 6, a high precipitation event, with a total of 50 mm in La Villa and 60 mm at Piz la Ila, occurred on the 28 and 29 November. The day after a sudden drop of both minimum and maximum air temperatures took place and both remained below 0° until 24 December; in some days, inversions of minimum temperatures were recorded between La Villa and Piz la Ila, but since all values were well below 0°C, a contemporary snow thawing at higher elevations and water freezing at lower ones can be excluded.

This peculiar combination of high precipitations, shortly followed by a drastic lowering of air temperatures, may have almost completely saturated the thin and highly permeable till, generating a confined aquifer in it, with no possibility of discharge, thus rapidly increasing the saturated weight of the debris on the underlying weathered visco-plastic material. Low temperatures may have frozen up also the spring depicted by topographic maps near the village of Sottrù, within the landslide area. This may have led to the destabilization of the landslide sector between the spring itself and the lowermost pre-2012 scarps. A similar hypothesis has been made also for landslide events occurred in the Dolomites (e.g., in Zoldo Valley in 1991) (Govi et al., 1993).
