**UNIVERSITÀ DEGLI STUDI  
DI MODENA E REGGIO EMILIA**

**Dottorato di ricerca in Ingegneria Industriale e del Territorio/ Industrial and  
Environmental Engineering**

**CMAS corrosion resistance of thermal barrier  
coatings (TBCs): influence of the coating  
microstructure, materials and architecture**

Candidato: Stefania Morelli

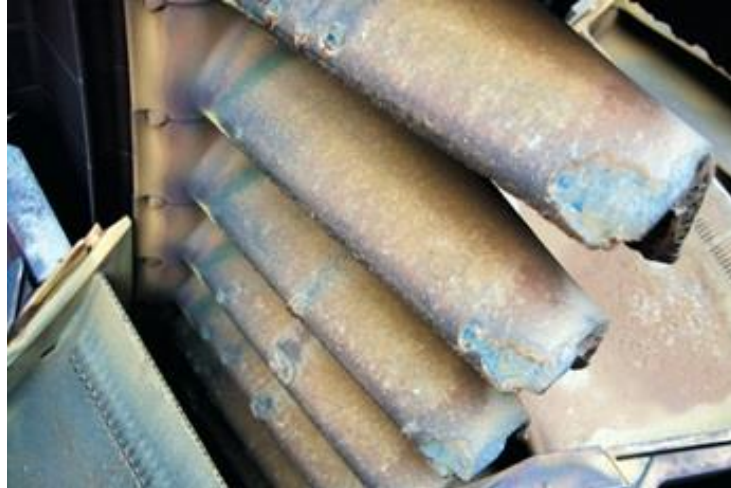
Figure 3 Hot corrosion damage of turbine blades [7]

6. **corrosion failures:** the intake air can also contain sodium and chlorine, or others atmospheric contaminants depending on where the gas turbines are placed. Moreover, they are continuously exposed to a strongly oxidising conditions and to fuel contaminants such as sulphur or vanadium. To reduce the corrosion of the nickel super-alloy, many protective coatings were employed. In particular, metallic coatings based on chromium and aluminium provides protection against oxidation.

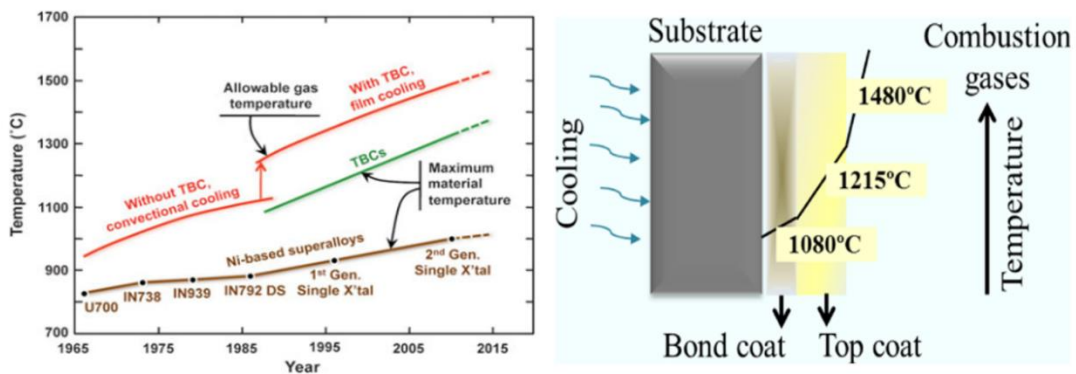
Figure 4 a) progression of the operating temperatures of Ni-based superalloy and thermal barrier coatings; b) variation in the combustion gas temperature by the application of TBCs to a substrate [10]

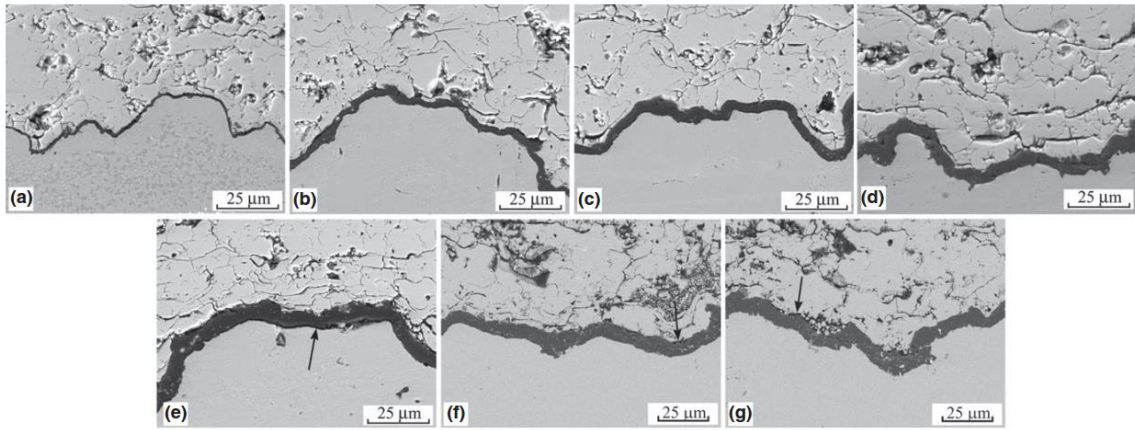
Figure 24 Evolution of TGO thickness after thermal exposure at 1080 °C for 20 h (b), 50 h (c), 105 h (d), 225 h (e), 300 h (f), and 350 h (g); (a) 1.3 μm, (b) 2.7 μm, (c) 3.9 μm, (d) 5.0 μm, (e) 6.5 μm, (f) 7.0 μm, and (g) 7.7 μm [59]

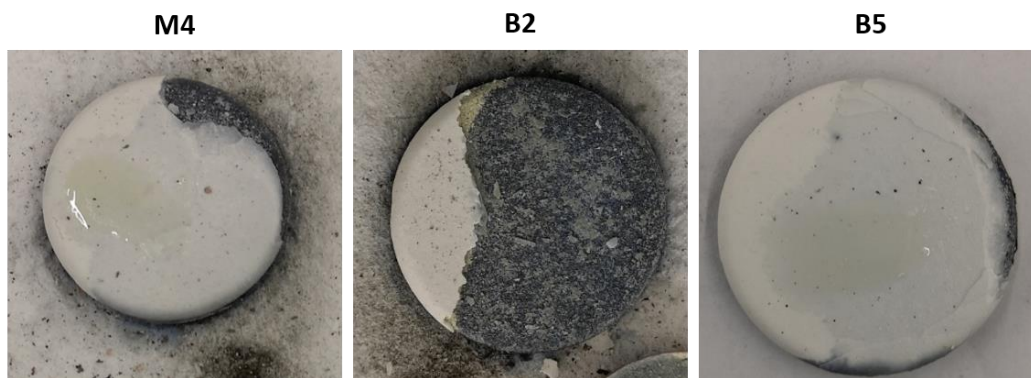
*Figure 61 Photographs of samples M4, B2 and B5 after CMAS corrosion test*

In Figure 61, macroscopic photographs of the samples after CMAS corrosion tests are reported. From the micrographs acquired on sample M4, i.e. the Gd/Yb/Y co-doped ZrO<sub>2</sub> monolayer (Figure 62A), it is apparent that molten CMAS, some of which remained as a layer on top of the coating, penetrated the vertical cracks. This can also be seen through EDX maps of sample B2 (Figure 63). EDX maps were useful to evaluate the CMAS infiltration at a macroscopic level, but they do not provide much information on the chemical interaction between the CMAS melt and the coating. As noted in Section 4.1, slight branching of the segmentation cracks along the interface between the deposition passes is visible (Figure 60B and Figure 62A - see circle).
