Virtual reconstruction of damaged archaeological sites based on Unmanned Aerial Vehicle Photogrammetry and 3D modelling. Study case of a southeastern Iberia production area in the Bronze Age / Carvajal-Ramírez, F.; Navarro-Ortega, A. D.; Agüera-Vega, F.; Martínez-Carricondo, P.; Mancini, F.. - In: MEASUREMENT. - ISSN 0263-2241. - 136:(2019), pp. 225-236. [10.1016/j.measurement.2018.12.092]

Virtual Reconstruction of Damaged Archaeological Sites based on Unmanned Aerial Vehicle Photogrammetry and 3D Modelling. Study Case of a Southeastern Iberia Production Area in the Bronze Age

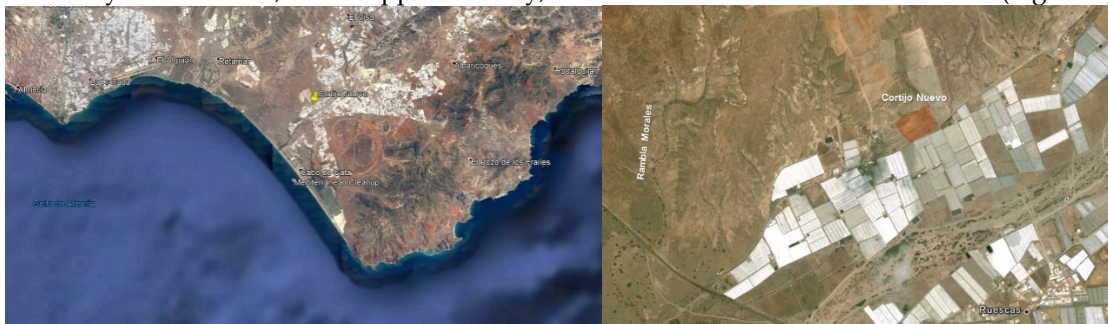
Figure 1. Study area. The location of Cortijo Nuevo is now in a greenhouse intensive agriculture zone.

The studied archeological site is located in Almería province, southeastern Spain, with geographic coordinates 36°49'24.5"N latitude, 2°13'59"W longitude. Almería province has evidences of ancient societies including remains of Roman establishment, salt extraction mines and coastal infrastructures, an Islamic city with necropolis, defensive walls and fortress [23]. Cortijo Nuevo is delimited by an area of 22,360 m² approximately, close to Rambla Morales and Ruescas (Figure 1).

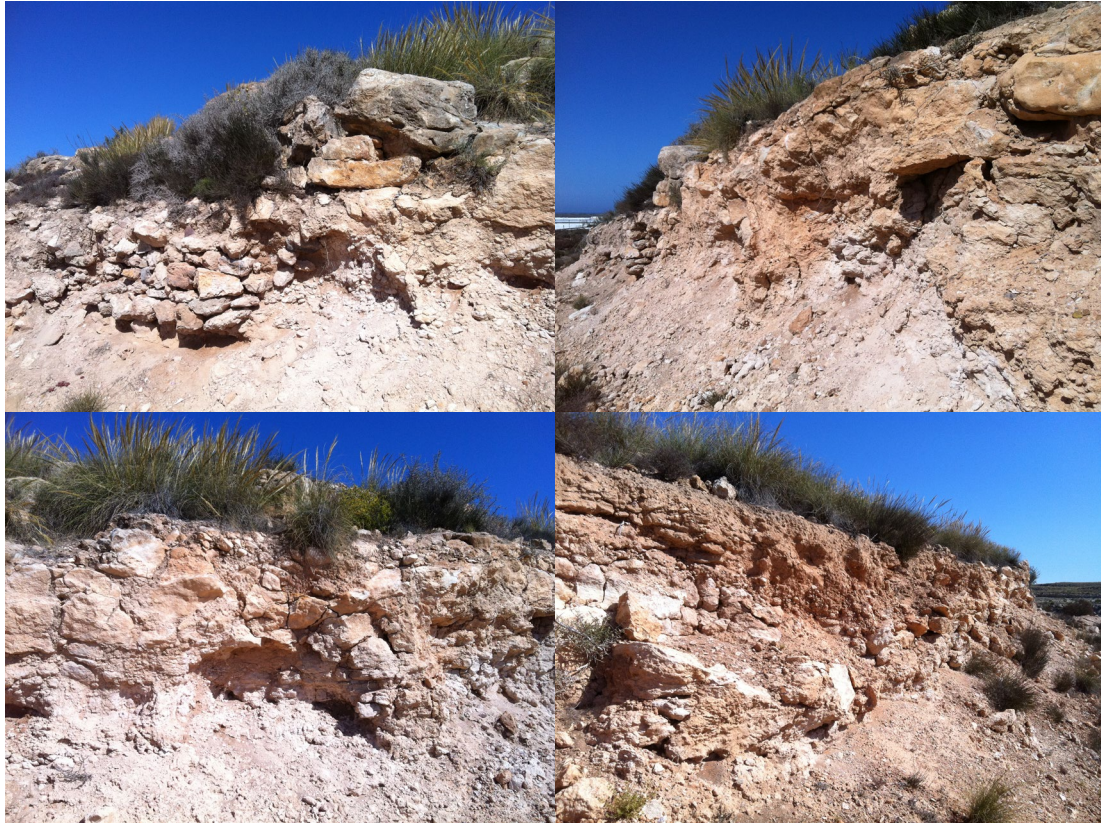
Figure 5. (a) Photogrammetric flight made in 1984–1985. (b) RGB orthoimage made in 1998–1999. (c) Altered front slope. Evidence of structures at present.

A few years after the declaration of high protection level, in 1994 the structures were severely damaged by a drilling machine, which was reported to the authorities. Figure 5a shows an official orthoimage made by the Spanish Government where extensive agriculture infrastructures have been developed close to the site, but the structures were not altered in 1984–1985. Figures 5b and 5c show evidence of the damage and new leveling for intensive agricultural activity, observed in the RGB orthoimage obtained by the Andalusian Government in 1998–1999 and on the site respectively.

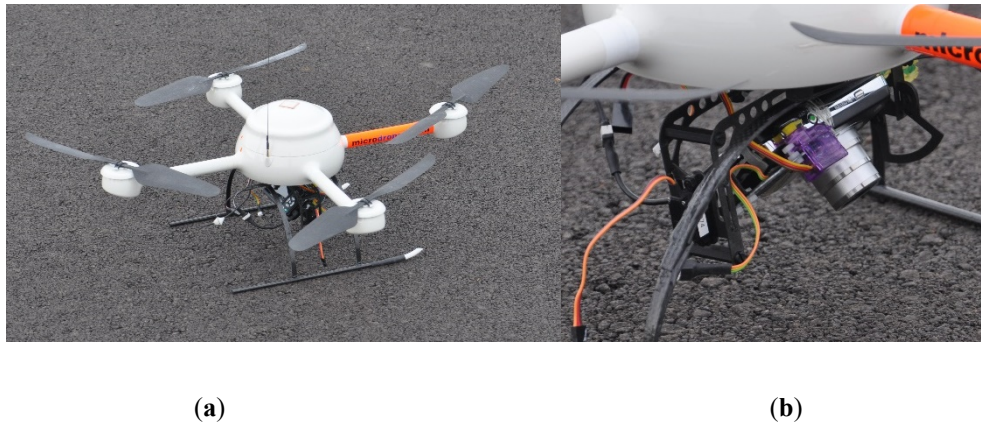
Figure 6. (a) Microdrones md4-200. (b) Detail of digital camera Pentax Optio A40 and gimbal on board.

A rotary-wing quadcopter UAV was used, model Microdrones md4-200 [30], with programmable capabilities for flight routes and actions at each waypoint on the flight. The payload is a maximum of 200 g, enough for carrying a compact digital camera, model Pentax Optio A40, with 12 megapixels, and the gimbal that stabilises the camera (Figure 6).

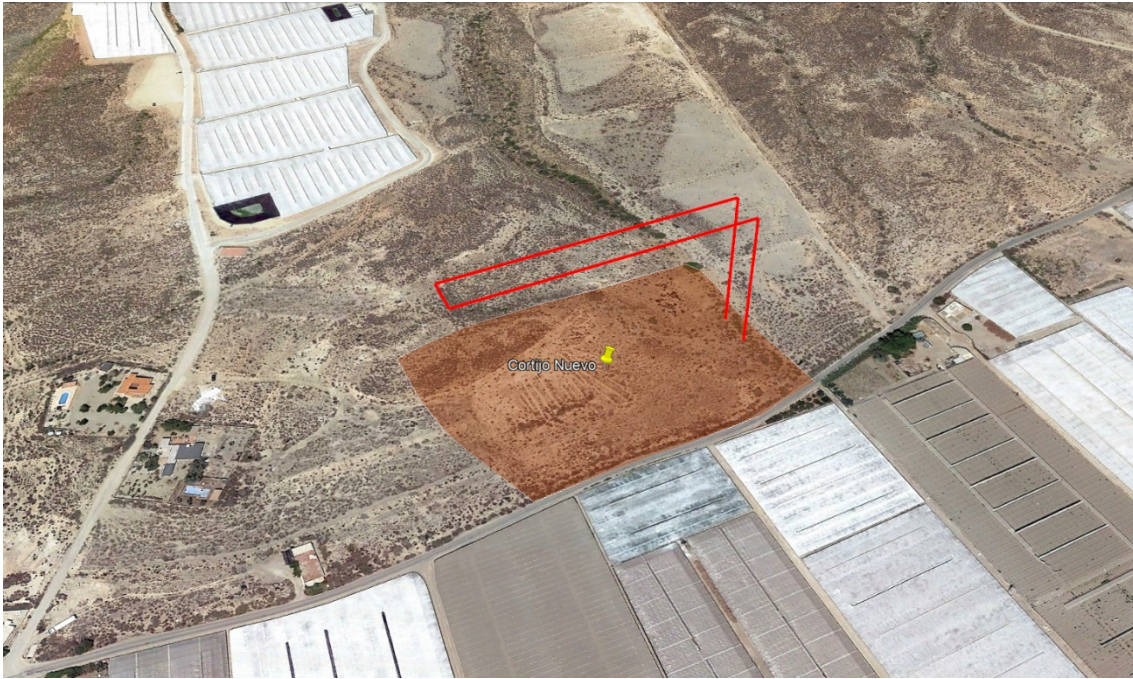
Figure 7. Target area to be covered by the photogrammetric flight and the two central paths of flight.

The target area to be covered by the photogrammetric flight was close to 2.2 ha and is located at the main damage to the architectural complex. Figure 7 shows the evidence of the cutting, drilling marks and the unaltered terrain surface in the northwest of the site. The limits of the flight area were the dividing line of the natural slope at the north, the road at the south, the watercourse axis at the east and the terraced plot at the west.

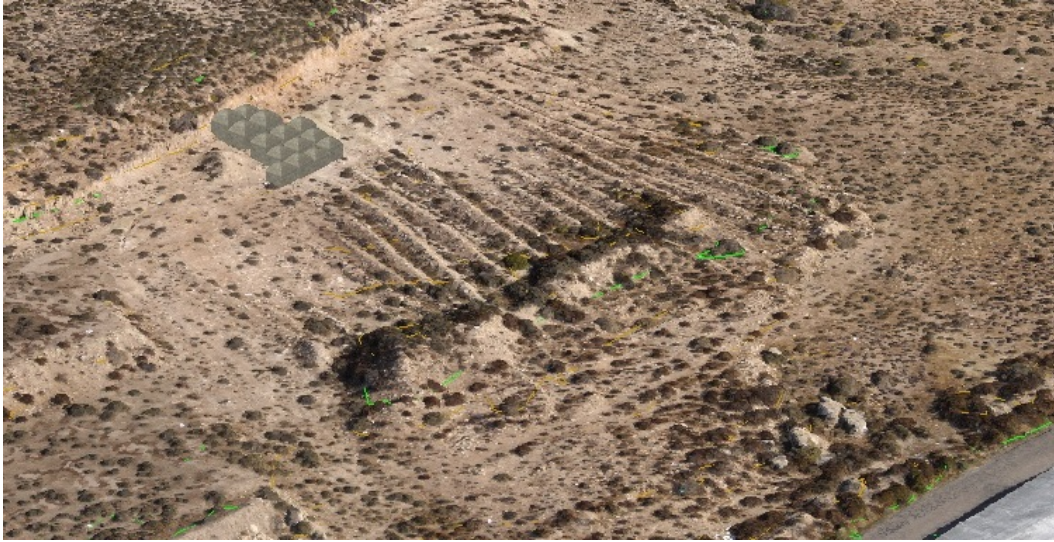
Figure 13. (a) Architectural structure model overlapped with point cloud obtained from UAV-Photogrammetric representation the current altered surface. (b) New TIN surface interpolated representing the original terrain morphology, with 1-m contours. Vaults can be observed over the slope level.

The architectural of the complex including structures, vaults and interconnection channels was represented according to descriptions registered in both archaeological campaigns [23,29] and based on the evidence obtained by UAV-Photogrammetry about current and past terrain morphology of the archaeological site. The surface of the bases and the depth of the structures used for the 3D model were measured in the excavation works. A total of 13 structures well-adapted to the geologic slope were distributed in five levels, containing 4, 3, 3, 2 and 2 structures respectively, from the lower to higher elevations (Figure 13). The bases of all the structures over the geological terrain were represented by the point cloud obtained by UAV-Photogrammetry, while tops of the structures were based on the unaltered level terrain, represented by the interpolated TIN. The vaults appear above the the ground level where the site is unaltered, and the interconnections between bottoms of structures at the same level are aligned with the contours. All the virtual structures were covered with a texture of limestones engaged with mud.
