RECOGNITION OF ANCIENT FIRES IN ARCHAEOLOGICAL SITES CONTAINING GYPSUM ROCKS

S. Lugli

Abstract

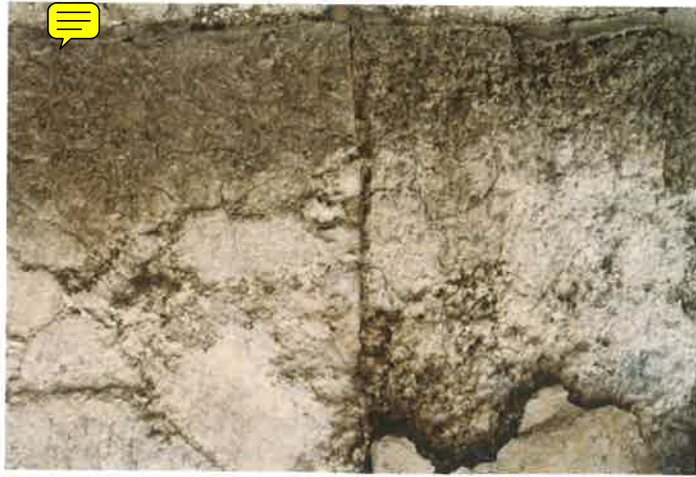
Fig. 3 – Partially dehydrated gypsum blocks (white) in the western façade of the Palace of Minos at Knossos (Crete). Note that the boundary of the white surface correlates across different blocks, indicating that the blocks were dehydrated after their emplacement. The lower portion of the gypsum blocks are unaltered (dark gray), suggesting that the socle may have acted as a sort of shield against the fire («shield shadow»). This interpretation is supported by the observation that the gypsum blocks are completely affected by the white surface in those tracts where socle is missing (not visible on picture). The gray areas on gypsum blocks are concrete restorations. Vertical blocks are about 60 cm high.

Most of the gypsum blocks in the studied sites are affected by white surfaces totally or in part. The unaffected areas are commonly in the lower part of the blocks and correlate across the walls (*figs. 3 and 4*). The presence of sharp unaffected surfaces in the white blocks could be interpreted as the shield effect to direct heat by fallen blocks, bricks, roofing-tiles, beams or other objects. In some examples in the Minoan Palace of Cnossos the shield against fire may have been the socle (*fig. 1*). This interpretation is supported by the observation that gypsum blocks are completely affected by white surfaces in those tracts where socle is missing.

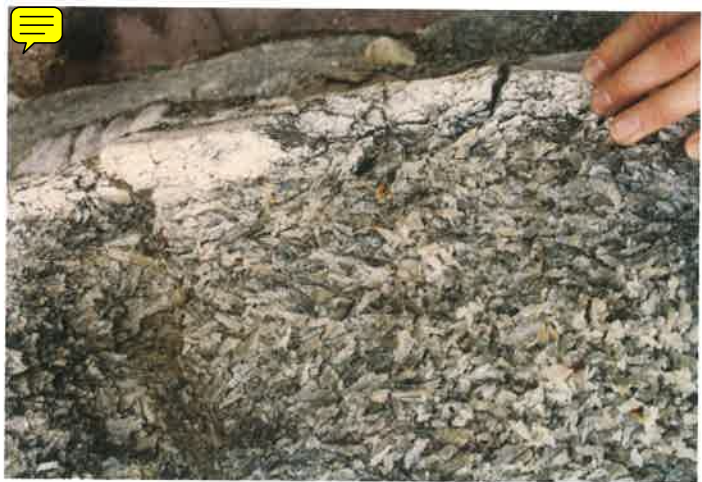
Fig. 4 – Close-up of the wall structure of *fig. 3* (Palace of Minos, Knossos, Crete). Note that the white surface cut through blocks with different crystal orientations, indicating that dehydration occurred after emplacement of the blocks.
