EFFECT OF CHLORINATED WATER ON THE OXIDATIVE RESISTANCE AND THE MECHANICAL STRENGTH OF POLYETHYLENE PIPES

D. Castagnetti*, G. Scirè Mammano and E. Dragoni

Dept. of Engineering Sciences and Methods, Univ. of Modena and Reggio Emilia

ABSTRACT

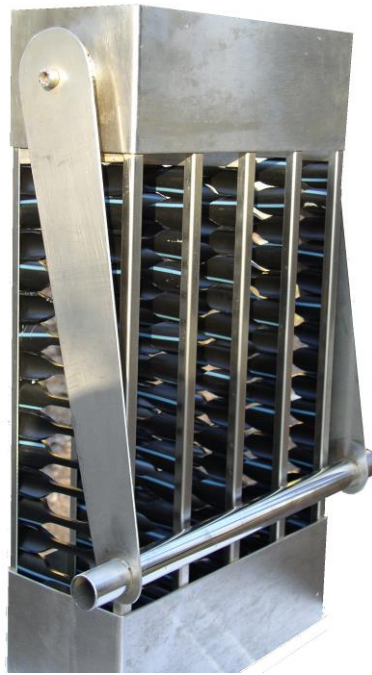
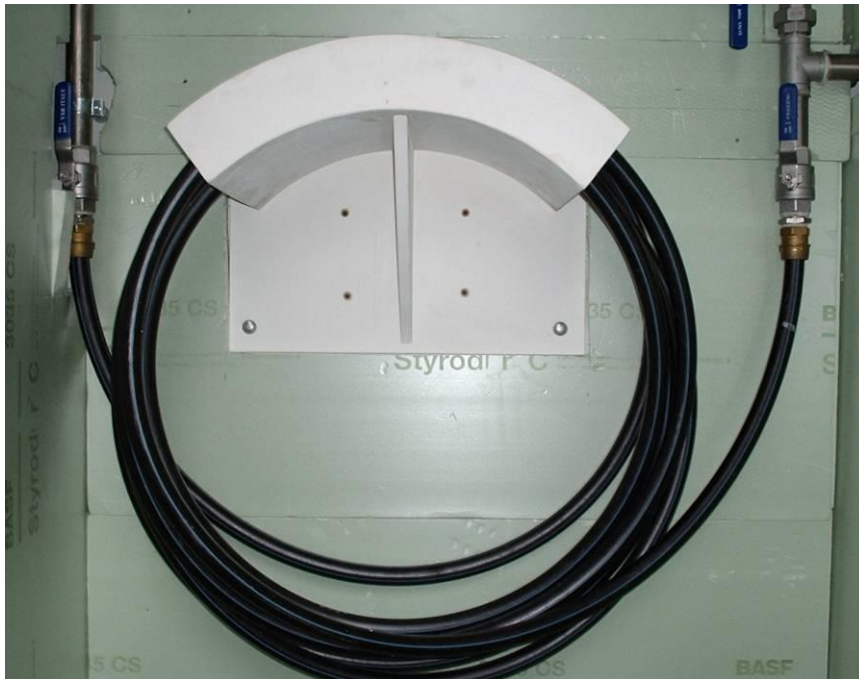
Figure 2 Type of specimens exposed in the plant during the experimental campaign: dog-bone specimens in the basket to be placed in the tank (a) and pipe coil in the hang (b)

The pre-cut dog-bone specimens were placed in a thermally insulated tank, which was accessible from the top, and installed serially in each exposure line. The specimens were accommodated in a specific basket hung in the tank (Figure 2a), which allows the water to flow around the whole surface of the specimens. Due to the wide diameter of the tanks with respect to the cross section of the main lines, the water speed was almost zero in the tank volume. Specimens were inserted and extracted by opening the top of the tank, an operation that required less than thirty minutes to be performed. In the process, neither the plant nor the tank needed to be emptied out but only de-pressurized so that the extraction only minimally affected the chemical and physical parameters of the system. I am not sure about the tenses used here. Maybe the present is appropriate, but I suggest you check to see how other authors manage the same situation.

The pipe to be exposed to the water was inserted in the line in the form of an off-the-shelf multi-coiled section (Figure 2b). The coils were enclosed in a thermally-insulated wooden box, in order to keep both the water running in the pipe and the pipe wall itself at constant temperatures.
